Scajaquada Creek Stream Assessment

Prepared by: Watershed Analysis Team
Dr. Kelly M. Frothingham, Course Instructor, GEG 421/521
Shafeeqah Ahmed, Jacob Bauer, Joseph Bodnarchuk, Emily Burch, Mark Clark,
Natasha Davrados, Mikail Gollwitzer, Stephanie Hanson, Natalie Neilsen,
Zachary Neudeck, Jason Paeplov, Mary Pokorski, Michael Radomski, Leah
Santasiero, Chad Schuster, Molly Talor, Jacob Trzepakowski

February 2017

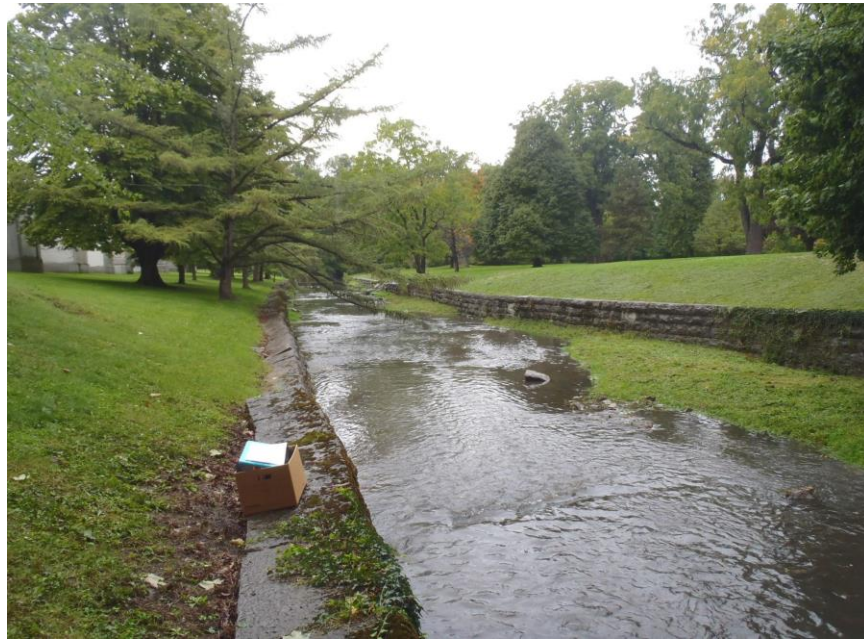
Figure 3.2 Reach 5, located at 42.924°N, -78.85979°W.

Reach 5 is located at the upstream-most section of the project area (Figure 3.2; see also Figure 1.5). Reach 5 is immediately downstream of a bridge, the channel is straightened, and the streambanks consist of stone walls. There is moderate sediment aggradation adjacent to the base of the stone walls in the channel. Grass on those bars appears to have been mowed. The riparian zone is dominated by mown grass with a few trees, especially near the downstream end of the reach along the right streambank. The overall SVAP score rating for Reach 5 is poor (score = 3.6) (Figure 3.3). The channel condition score is low (1; severely degraded) because greater than 50% of the reach is channelized with hard structures along the streambanks. There also is evidence of sediment aggradation in the channel and the channel appears to be disconnected from the floodplain. Both streambanks received fair bank condition scores (5 left bank and 6 right bank) because of the stone wall along the streambanks, some evidence of wall failures, and the presence of little to no vegetation. The lack of streamside vegetation also resulted in low riparian zone scores for both banks (1 left bank and 2 right bank; severely degraded). The water appearance score is fair (6), as turbidity is minimal and nutrient enrichment is good (7) due to minimal algal growth. Instream fish cover is poor (3) because cover is limited to cobble, overhanging vegetation, and undercut banks in the reach. Less than 20% of the water surface is shaded, which resulted in a severely degraded (1) canopy cover score.

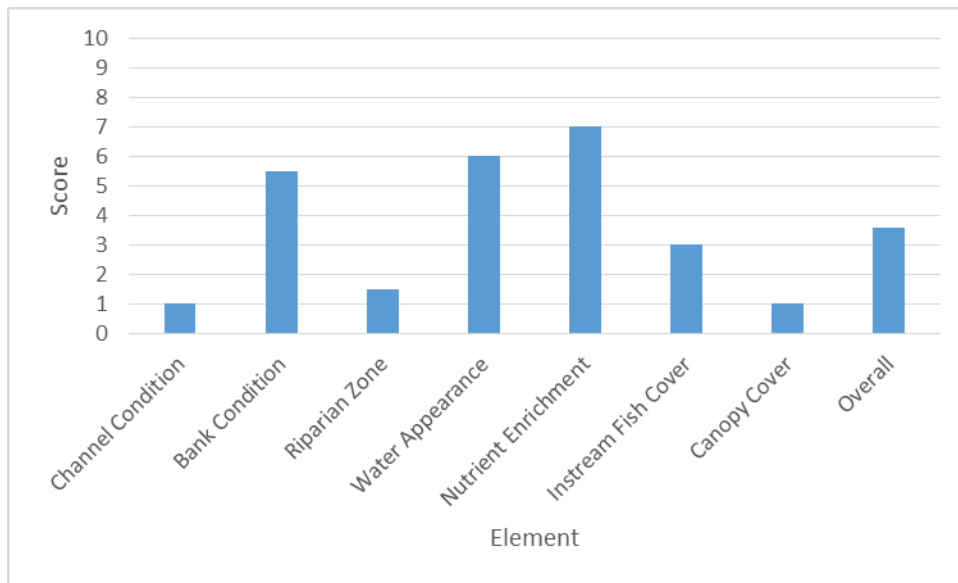
Figure 3.3 SVAP element and overall scores for Reach 5.

SVAP Element	2013		2016	
	Score	Rating*	Score	Rating ⁺
Channel Condition	2.0	Poor	1.0	Severely Degraded
Bank Stability/Condition (average)	10.0	Excellent	5.5	Fair
Riparian Zone (average)	1.0	Poor	1.5	Severely Degraded
Water Appearance	8.0	Good	6.0	Fair
Nutrient Enrichment	7.0	Fair	7.0	Good
Instream Fish Cover	4.0	Poor	3.0	Poor
Canopy Cover	2.0	Poor	1.0	Severely Degraded
Overall Score	5.2	Poor	3.6	Poor

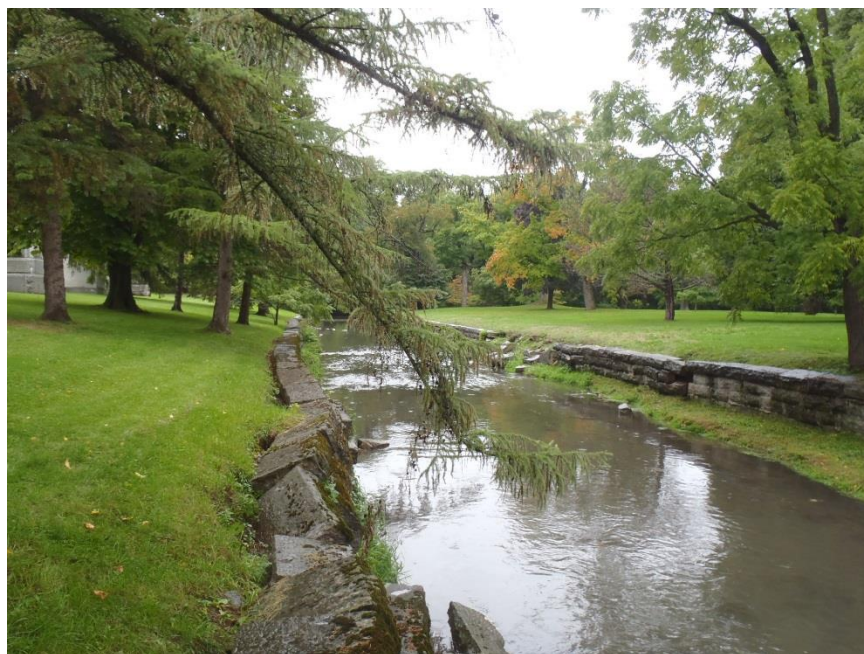
Figure 3.4 Reach 6, located at 42.92413°N, -78.22°W.

Reach 6 is located downstream of Reach 5 (Figure 3.4). This reach is channelized with stone block walls that are failing in multiple areas along both banks. Sediment aggradation is evident in the channel along the

base of the stone walls. Riparian vegetation consists of mown grass with a minimal number of trees located several feet away from the top of the streambanks. The overall SVAP score rating for Reach 6 is severely degraded (score = 2.9) (Figure 3.5). The channel condition score is poor (3) because approximately 50% of the reach is channelized with hard structures along the banks. Both streambanks received low bank condition scores (2 left bank and 2 right bank; severely degraded) because of the stone wall along the streambanks, wall failures, and the presence of little to no vegetation. The lack of streamside vegetation also resulted in severely degraded riparian zone scores for both banks (1 left bank and 0 right bank). The water appearance score is fair (6), as turbidity is minimal and nutrient enrichment is good (7) due to minimal algal growth. Instream fish cover is severely degraded (1) because cover is limited to a few overhanging tree branches. Less than 20% of the water surface is shaded, which resulted in a severely degraded (0) canopy cover score.

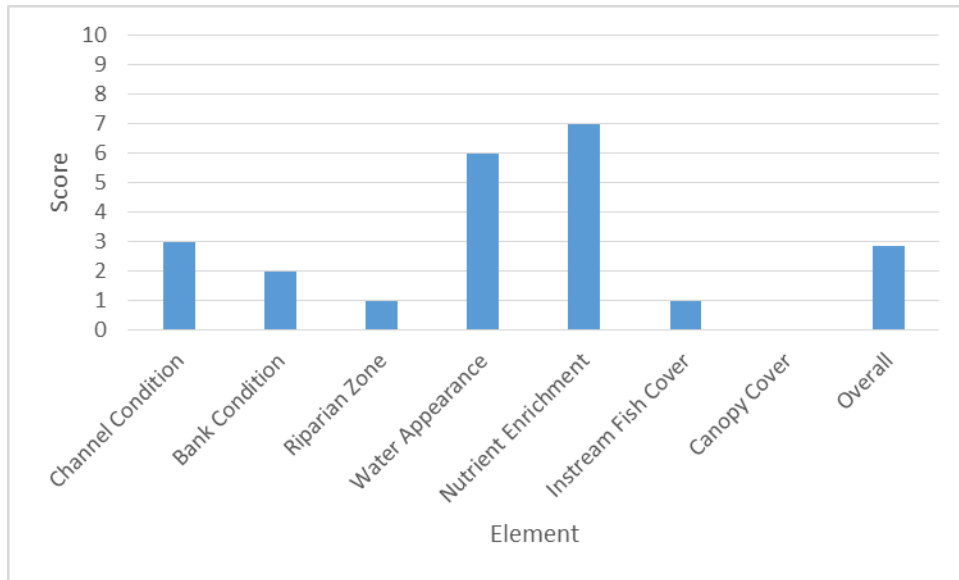
Figure 3.5 SVAP element and overall scores for Reach 6.

SVAP Element	2013		2016	
	Score	Rating*	Score	Rating ⁺
Channel Condition	1.0	Poor	3.0	Poor
Bank Stability/Condition (average)	10.0	Excellent	2.0	Severely Degraded
Riparian Zone (average)	1.0	Poor	1.0	Severely Degraded
Water Appearance	9.0	Excellent	6.0	Fair
Nutrient Enrichment	9.0	Excellent	7.0	Good
Instream Fish Cover	3.0	Poor	1.0	Severely Degraded
Canopy Cover	1.0	Poor	0.0	Severely Degraded
Overall Score	5.0	Poor	2.9	Severely Degraded

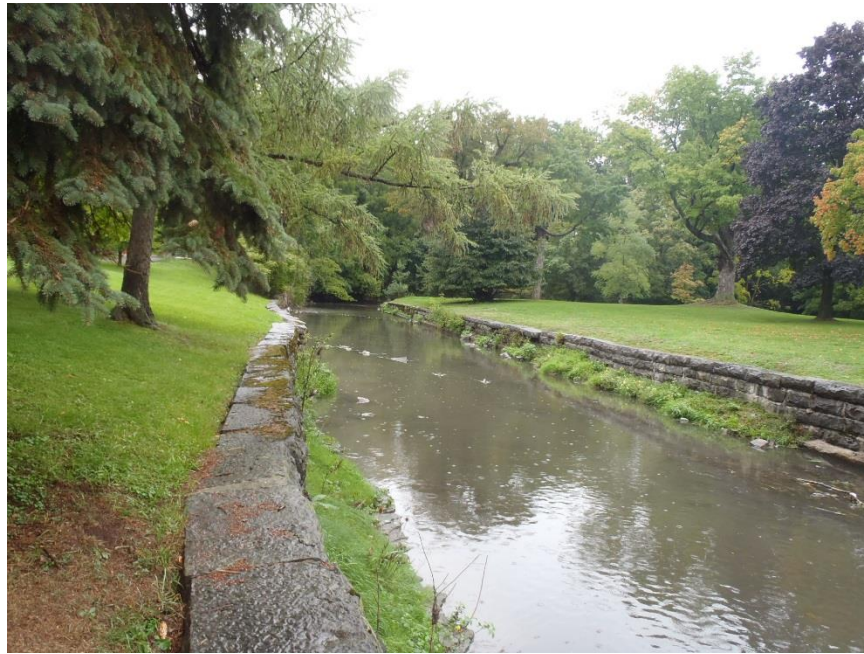
Figure 3.6 Reach 7, located at 42.92432°N, -78.86079°W.

Reach 7 is located downstream of Reach 6 (Figure 3.6). This reach is shallow and straightened with the stream bed consisting of shale rock, mud, and silt. There is very little canopy cover with only two trees on the left bank. The riparian areas on both sides of the stream are mowed to the top of the streambanks, which have stone walls with sediment accumulation in the channel along the base of the walls. The overall SVAP score rating for Reach 7 is severely degraded (score = 2.3) (Figure 3.7). The channel condition score is severely degraded (1) because greater than 50% of the channel was straightened with hard structures. The stone wall streambanks also are steep and some bank failures are visible. Both streambanks received low bank condition scores (3 left bank and 3 right bank; poor) because of the stone wall along the streambanks, wall failures, and the presence of little to no vegetation. The lack of streamside vegetation also resulted in severely degraded riparian zone scores for both banks (1 left bank and 1 right bank). The water appearance score is poor (3), as turbid conditions are noted and nutrient enrichment is good (7) due to minimal algal growth. Instream fish cover is severely degraded (1) because cover is limited to minimal amounts of overhanging vegetation. Less than 20% of the water surface is shaded, which resulted in a severely degraded (0) canopy cover score.

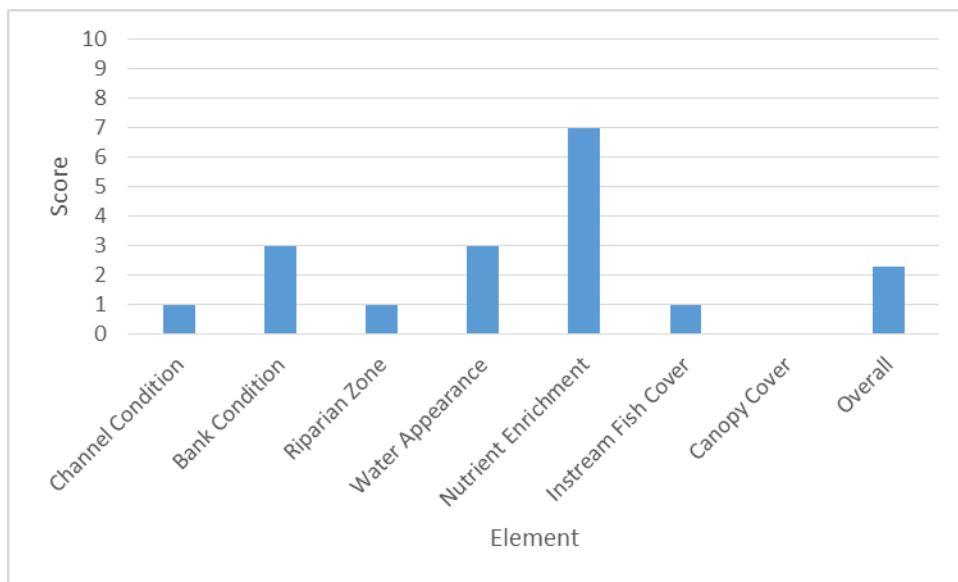
Figure 3.7 SVAP element and overall scores for Reach 7.

SVAP Element	2013		2016	
	Score	Rating*	Score	Rating+
Channel Condition	1.0	Poor	1.0	Severely Degraded
Bank Stability/Condition (average)	10.0	Excellent	3.0	Poor
Riparian Zone (average)	1.0	Poor	1.0	Severely Degraded
Water Appearance	8.0	Good	3.0	Poor
Nutrient Enrichment	7.0	Fair	7.0	Fair
Instream Fish Cover	2.0	Poor	1.0	Severely Degraded
Canopy Cover	1.0	Poor	0.0	Severely Degraded
Overall Score	4.7	Poor	2.3	Severely Degraded

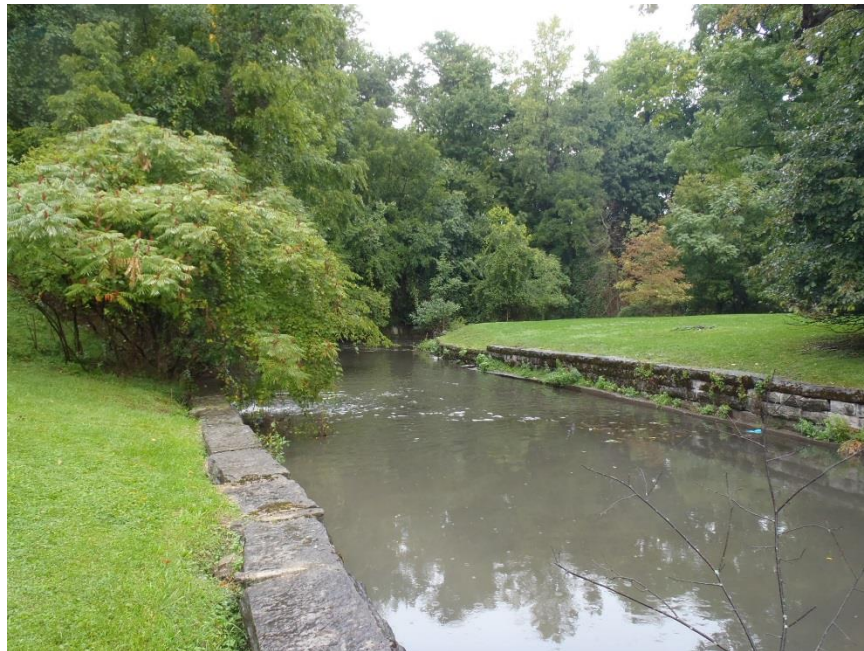
Figure 3.8 Reach 8, located at 42.92459°N, -78.86149°W.

Reach 8 is located downstream of Reach 7 and it is the last reach in the proposed upstream restoration area (Figure 3.8; see also Figure 1.5). Like the three upstream reaches, Reach 8 is channelized and the streambanks consist of a stone wall along both banks. Sediment aggradation in the channel along the base of

the stone walls is minimal in Reach 8. The upstream area of the riparian zone is predominately mowed grass and there are trees at the downstream end of the reach. The overall SVAP score rating for Reach 8 is severely degraded (score = 2.9) (Figure 3.9). The channel condition score is severely degraded (1) because more than 50% of the reach is channelized and lined with stone blocks. As such, there is little or no connection between the floodplain and stream channel. Both streambanks received low bank condition scores (2 left bank and 1 right bank; severely degraded) because of the stone wall along the streambanks, wall failures, and the presence of little to no vegetation. The lack of streamside vegetation also resulted in severely degraded riparian zone scores for both banks (1 left bank and 0 right bank). The water appearance score is fair (5), as slightly turbid conditions are noted and nutrient enrichment is fair (6) due to moderate algal growth on stream substrate. Instream fish cover is poor (3) because cover is limited to overhanging vegetation, riffles, and large woody debris. Between 20 and 49% of the water surface is shaded, which resulted in a poor (3) canopy cover score.

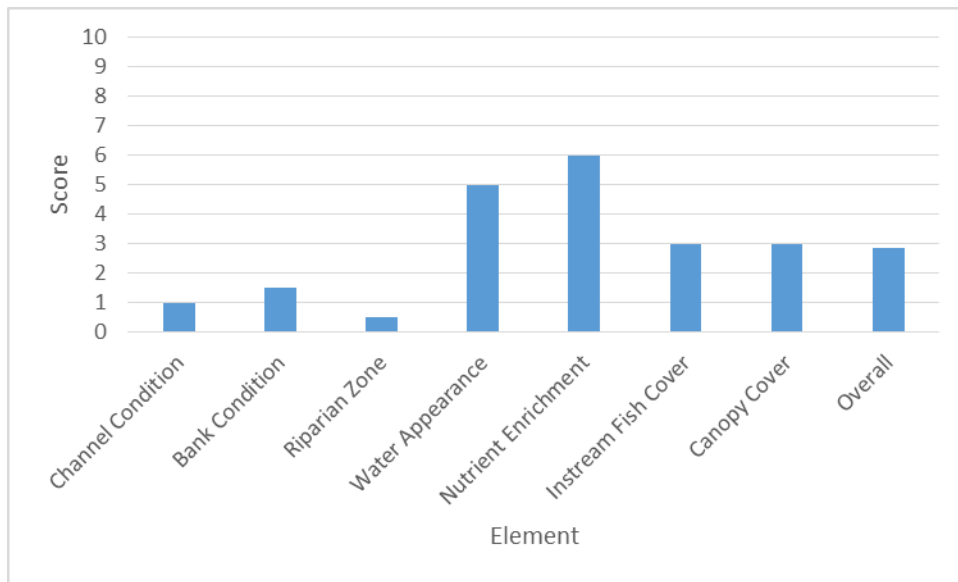
Figure 3.9 SVAP element and overall scores for Reach 8.

SVAP Element	2013		2016	
	Score	Rating*	Score	Rating+
Channel Condition	1.0	Poor	1.0	Severely Degraded
Bank Stability/Condition (average)	10.0	Excellent	1.5	Severely Degraded
Riparian Zone (average)	1.5	Poor	0.5	Severely Degraded
Water Appearance	8.0	Good	5.0	Fair
Nutrient Enrichment	7.0	Fair	6.0	Fair
Instream Fish Cover	7.0	Fair	3.0	Poor
Canopy Cover	1.0	Poor	3.0	Poor
Overall Score	6.0	Poor	2.9	Severely Degraded

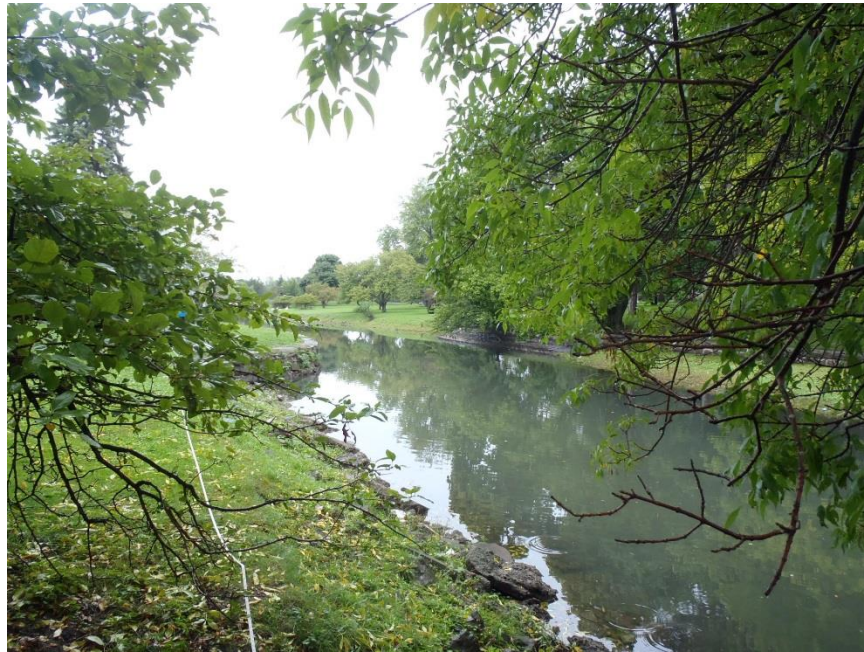
Figure 3.10 Reach 20, located at 42.9278°N, -78.86447°W.

Reach 20 is located at the upstream end of the proposed downstream restoration area (Figure 3.10; see also Figure 1.5). Reach 20 is straightened, the stone wall along the banks continues in this area of the creek, and there is a large (about six feet wide and several feet long) bar in the channel along the base of the right bank. The riparian zone consists of mown grass and a few trees and shrubs. The overall SVAP score rating for Reach 20 is severely degraded (score = 2.1) (Figure 3.11). The channel condition score is severely degraded (0) because more than 50% of the reach is channelized and rip rap was present in the reach. Both streambanks received low bank condition scores (1 left bank and 1 right bank; severely degraded) because of the rip rap and evidence of active bank failures. The streamside vegetation is limited to mown grass with very few plants, which resulted in severely degraded riparian zone scores for both banks (0 left bank and 1 right bank). The water appearance score is poor (3), as moderately turbid conditions are noted and nutrient enrichment is fair (6) due to moderate algal growth. Instream fish cover is poor (3) because cover is limited to overhanging vegetation, cobbles, and isolated backwater pools. Less than 20% of the water surface is shaded, which resulted in a severely degraded (1) canopy cover score.

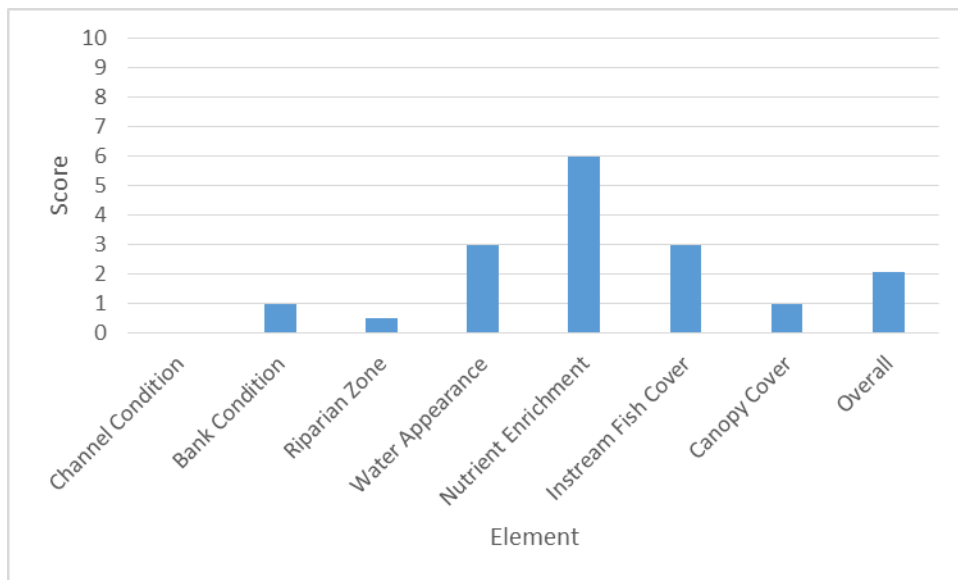
Figure 3.11 SVAP element and overall scores for Reach 20.

SVAP Element	2013		2016	
	Score	Rating*	Score	Rating+
Channel Condition	1.0	Poor	0.0	Severely Degraded
Bank Stability/Condition (average)	10.0	Excellent	1.0	Severely Degraded
Riparian Zone (average)	2.0	Poor	0.5	Severely Degraded
Water Appearance	2.0	Poor	3.0	Poor
Nutrient Enrichment	2.0	Poor	6.0	Fair
Instream Fish Cover	2.0	Poor	3.0	Poor
Canopy Cover	1.0	Poor	1.0	Severely Degraded
Overall Score	3.2	Poor	2.1	Severely Degraded

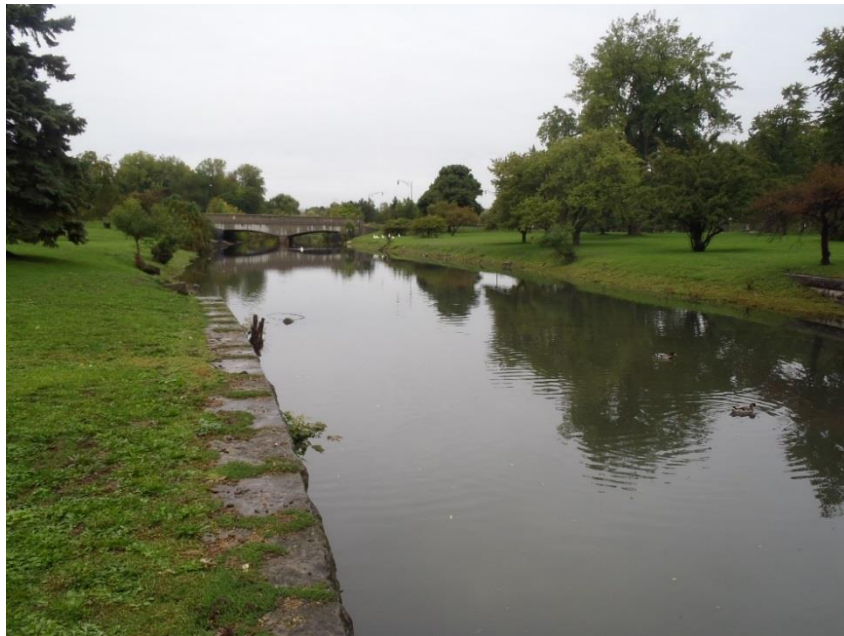
Figure 3.12 Reach 21, located at 42.92825°N, -78.8648°W.

Reach 21 is located downstream of Reach 20 (Figure 3.12). Reach 21 is channelized and the stone walls along the streambanks continue into this reach. The riparian zone consists of mown grass and a limited number of trees. The overall SVAP score rating for Reach 21 is severely degraded (score = 2.8) (Figure 3.13). The channel

condition score is severely degraded (2) because more than 50% of the reach was channelized and rip rap was present in the reach. Both streambanks received low bank condition scores (1 left bank and 2 right bank; severely degraded) because of the rip rap and evidence of active bank failures. The streamside vegetation is limited to mown grass with a few trees, which resulted in severely degraded riparian zone scores for both banks (1 left bank and 1 right bank). The water appearance score is poor (3), as moderately turbid conditions are noted and nutrient enrichment is fair (6) due to moderate algal growth. Instream fish cover is fair (5) because cover is limited to overhanging vegetation, cobbles, boulders, and large woody debris. Less than 20% of the water surface is shaded, which resulted in a severely degraded (1) canopy cover score.

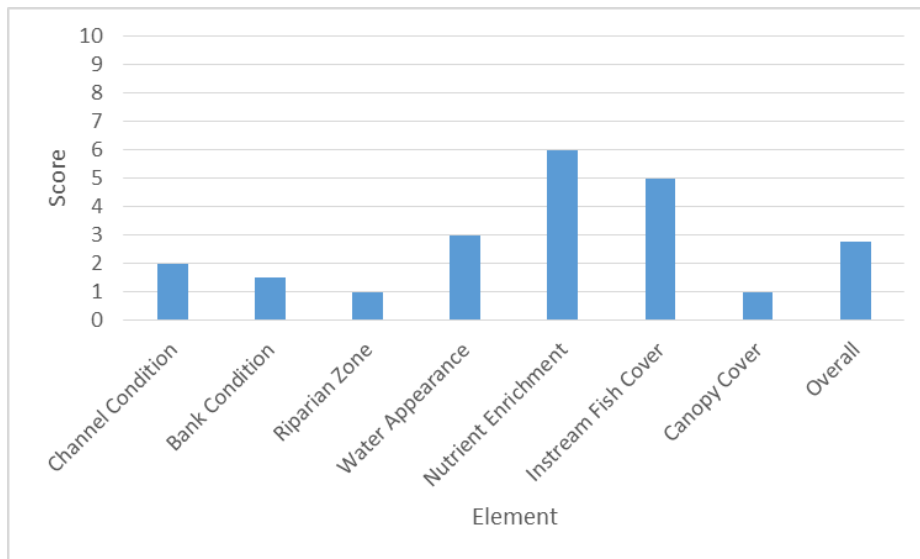
Figure 3.13 SVAP element and overall scores for Reach 21.

SVAP Element	2013		2016	
	Score	Rating*	Score	Rating ⁺
Channel Condition	2.0	Poor	2.0	Severely Degraded
Bank Stability/Condition (average)	9.0	Excellent	1.5	Severely Degraded
Riparian Zone (average)	1.0	Poor	1.0	Severely Degraded
Water Appearance	2.0	Poor	3.0	Poor
Nutrient Enrichment	3.0	Poor	6.0	Fair
Instream Fish Cover	1.0	Poor	5.0	Fair
Canopy Cover	1.0	Poor	1.0	Severely Degraded
Overall Score	3.3	Poor	2.8	Severely Degraded

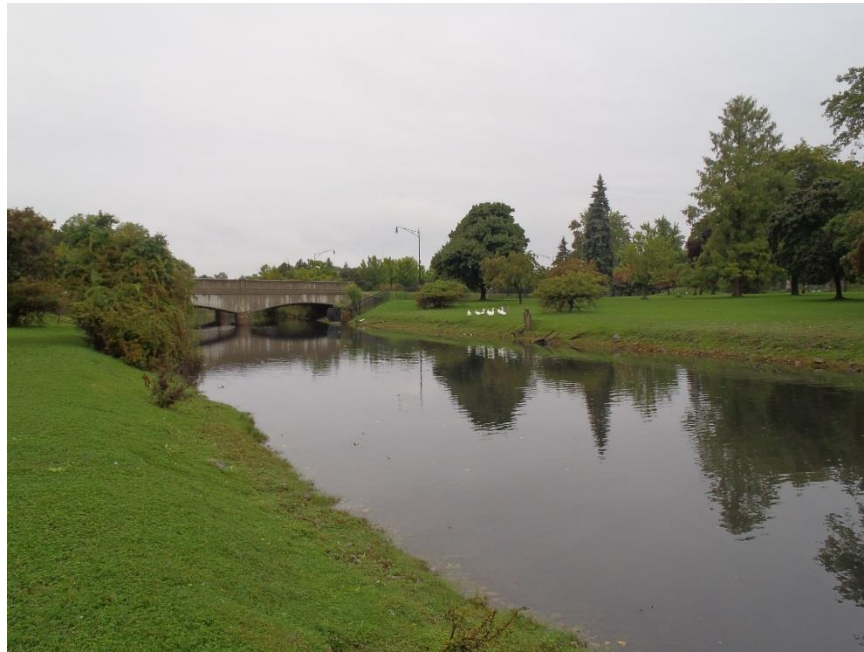
Figure 3.14 Reach 22, located at 42.92853°N, -78.86523°W.

Reach 22 is located downstream of Reach 21 and it is the most downstream section of the second proposed restoration area (Figure 3.14; see also Figure 1.5). This reach is located immediately upstream of the Delaware Road bridge. The stone wall that dominates all the other reaches is absent in Reach 21, but there is some rock rip rap present along the bank toe. The riparian zone consists of mown grass and a few shrubs. The overall SVAP score rating for Reach 22 is poor (score = 3.7) (Figure 3.15). The channel condition score is severely degraded (2) because more than 50% of the reach is channelized and rip rap is present in the reach. Streambanks received moderate bank condition scores (8 left bank and 6 right bank; good and fair, respectively) because of minimal rip rap and gentle slopes that appear moderately stable. The streamside vegetation is limited to mown grass, which resulted in severely degraded riparian zone scores for both banks (1 left bank and 1 right bank). The water appearance score is good (7), as conditions are slightly turbid and nutrient enrichment is good (7) due to fairly clear water conditions along the entire reach. Instream fish cover is severely degraded (0), as no cover types are noted. Less than 20% of the water surface is shaded, which resulted in a severely degraded (2) canopy cover score.

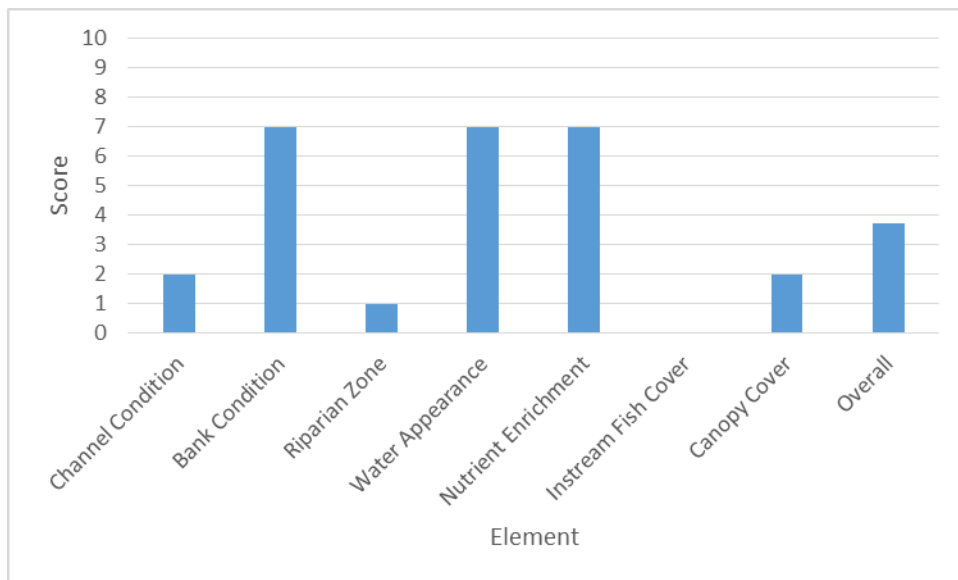
Figure 3.15 SVAP element and overall scores for Reach 22.

SVAP Element	2013		2016	
	Score	Rating*	Score	Rating ⁺
Channel Condition	2.0	Poor	2.0	Severely Degraded
Bank Stability/Condition (average)	10.0	Excellent	7.0	Good
Riparian Zone (average)	1.0	Poor	1.0	Severely Degraded
Water Appearance	3.0	Poor	7.0	Good
Nutrient Enrichment	2.0	Poor	7.0	Good
Instream Fish Cover	1.0	Poor	0.0	Severely Degraded
Canopy Cover	1.0	Poor	2.0	Severely Degraded
Overall Score	3.2	Poor	3.7	Poor
