Scajaquada Creek Stream Assessment: Post Project Monitoring

Prepared by: Watershed Analysis Team
Dr. Kelly M. Frothingham, Course Instructor, GEG 421/521
Joshua Allan, Hunter Bogdan, Tyler Dannhauser, Leah Domiano, Kevin Harper,
Lauren Martinek, Brinna Saylor, Corinna Solomon, and Benjamin Wrazen

December 2019

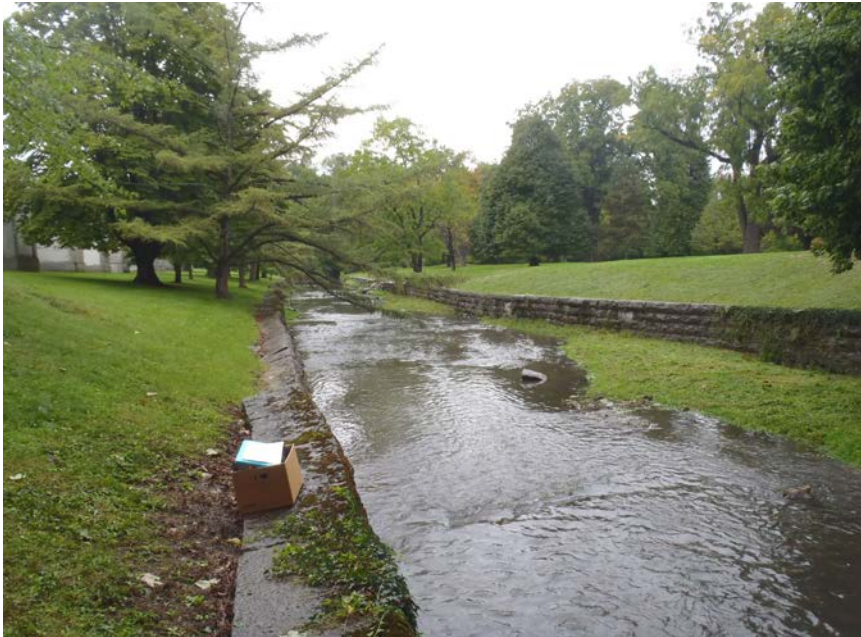
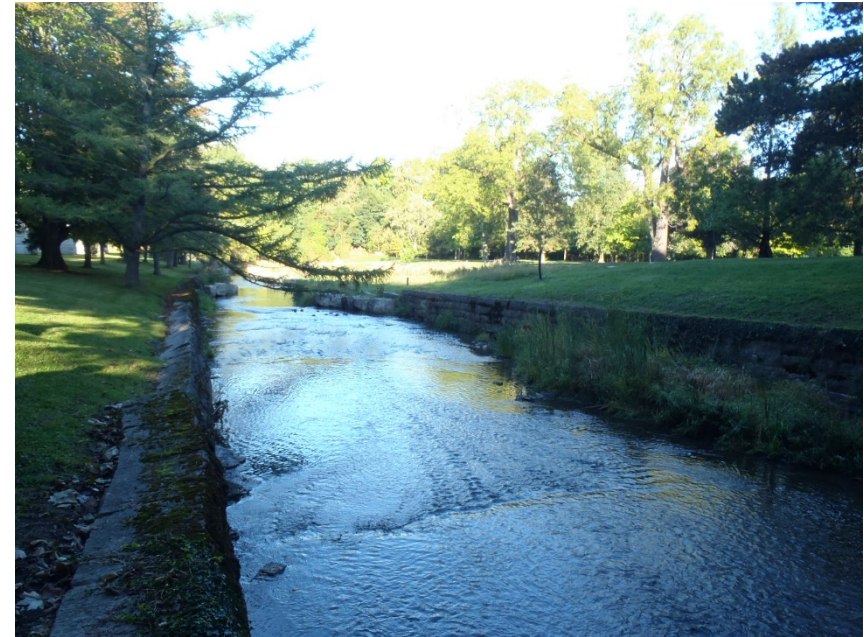
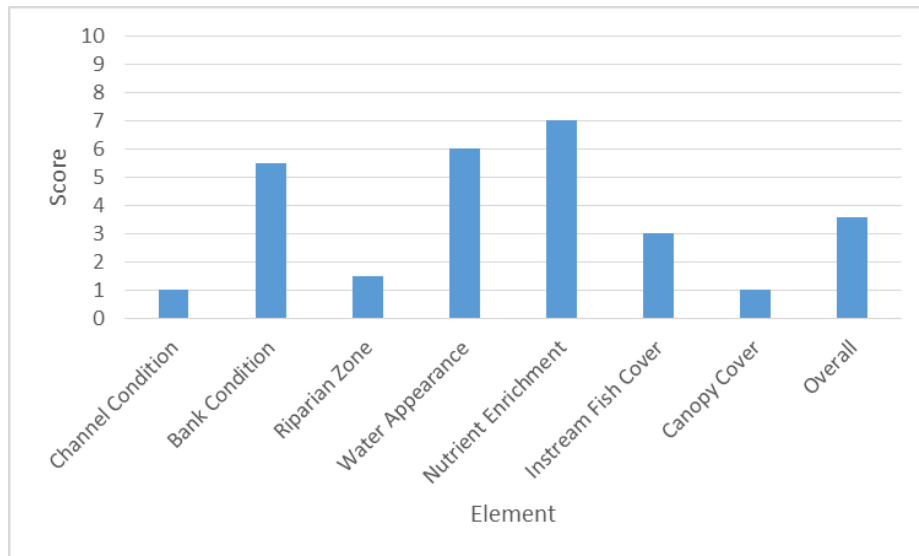
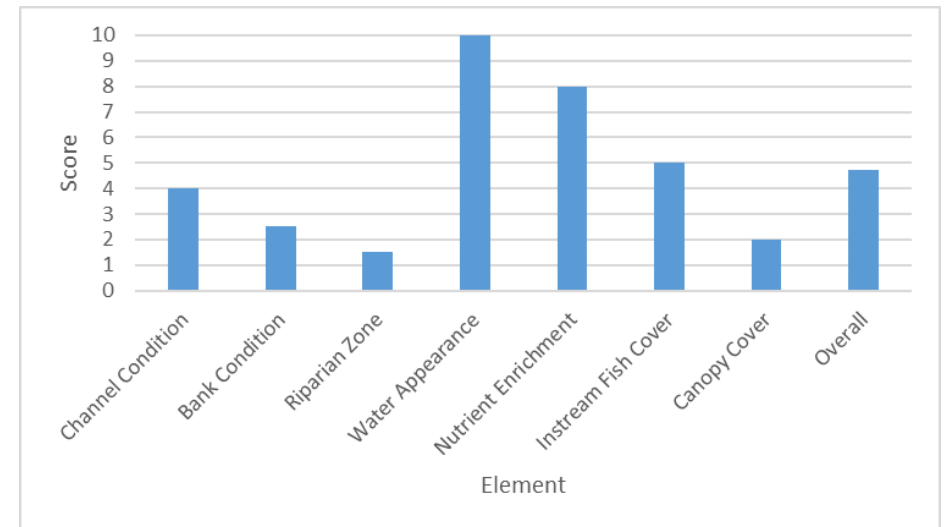
Figure 3.1 Reach 5, located at 42.924°N, -78.85979°W. Pre-construction SVAP on left (Frothingham et al., 2017) and post-construction on right.

SVAP Element	Score	Rating	Notes
Channel Condition	4.0	Poor	Altered channel, straightened, hard structures; bankfull channel disconnected from floodplain along both streambanks
Bank Condition (average)	2.5	Severely Degraded	Limestone blocks dominate banks; streambanks are stable
Riparian Zone (average)	1.5	Severely Degraded	Little to no vegetation along left streambank; some emergent aquatic vegetation along right bank; mowed lawn dominates riparian zone
Water Appearance	10.0	Excellent	Water clear and submerged objects are visible
Nutrient Enrichment	8.0	Good	Fairly clear water; moderate algal growth on stream substrates
Instream Fish Cover	5.0	Poor	Overhanging vegetation, dense macrophyte beds, riffle, bendway weir
Canopy Cover	2.0	Severely Degraded	Less than 20% of water surface shaded within the length of the reach
Overall Score	4.7	Poor

2016		2019	
SVAP Element	Score	Rating	Score	Rating
Channel Condition	1.0	Severely Degraded	4.0	Poor
Bank Condition (average)	5.5	Fair	2.5	Severely Degraded
Riparian Zone (average)	1.5	Severely Degraded	1.5	Severely Degraded
Water Appearance	6.0	Fair	10.0	Excellent
Nutrient Enrichment	7.0	Good	8.0	Good
Instream Fish Cover	3.0	Poor	5.0	Poor
Canopy Cover	1.0	Severely Degraded	2.0	Severely Degraded
Overall Score	3.6	Poor	4.7	Poor

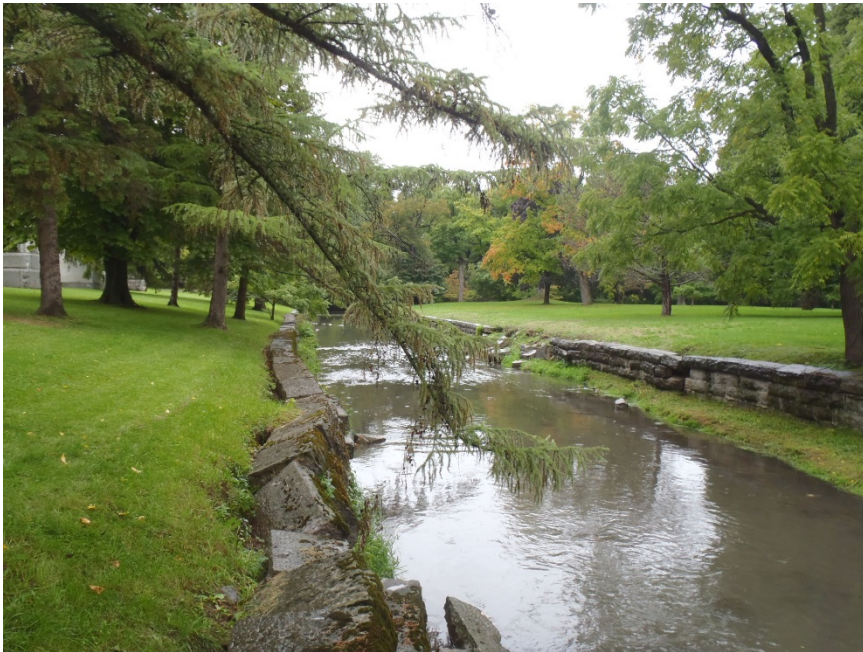
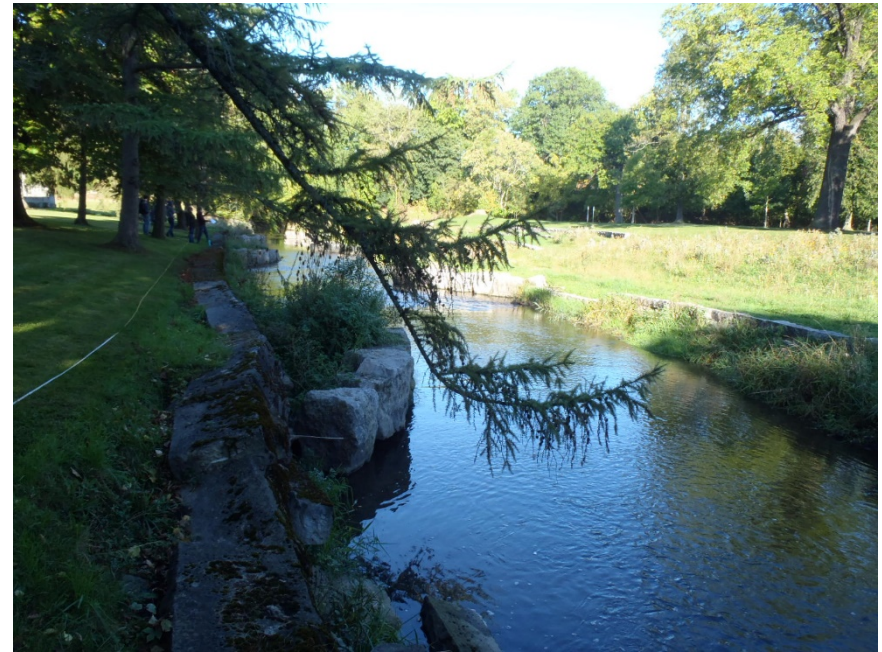
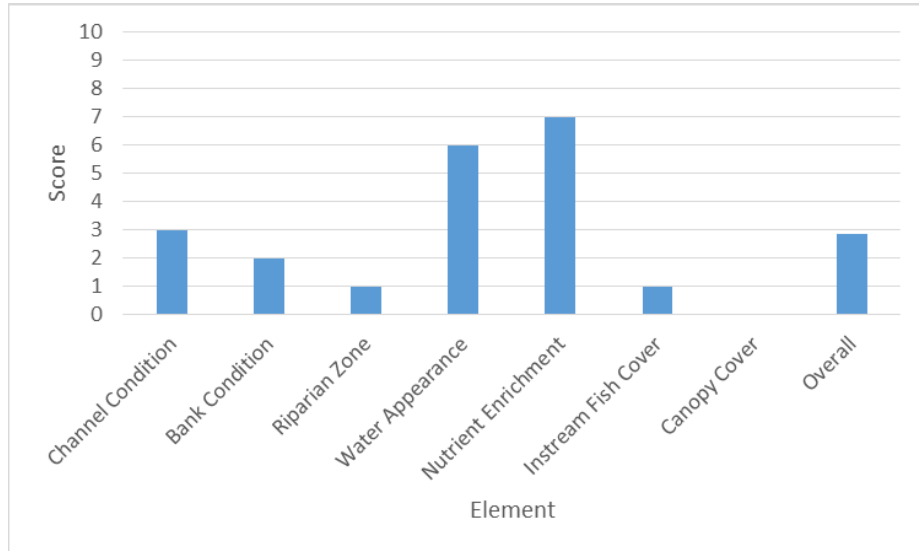
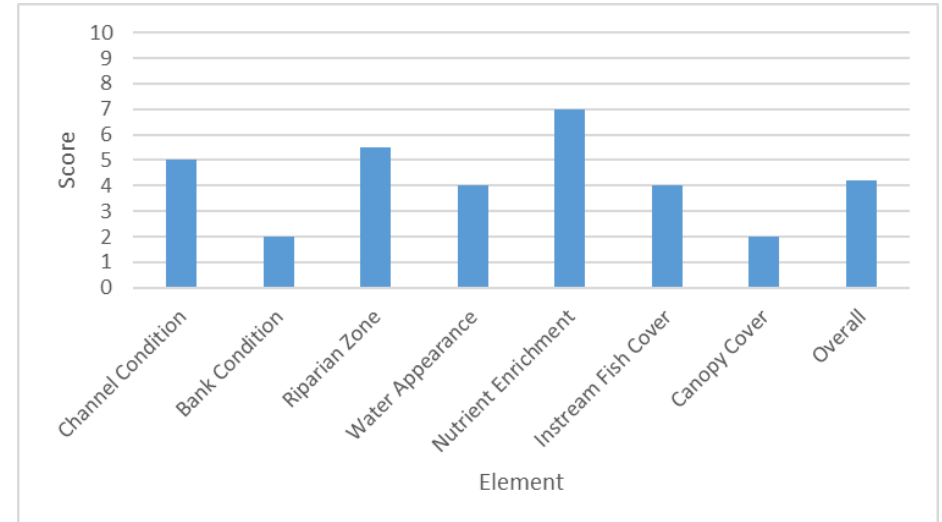
Figure 3.2 Reach 6, located at 42.92413°N, -78.22°W. Pre-construction SVAP on left (Frothingham et al., 2017) and post-construction on right.

SVAP Element	Score	Rating	Notes
Channel Condition	5.0	Poor	Altered channel, straightened, hard structures; bankfull channel disconnected from floodplain along left streambank
Bank Condition (average)	2.0	Severely Degraded	Limestone blocks dominate banks (especially left streambank); streambanks are moderately stable
Riparian Zone (average)	5.5	Fair	Little to no vegetation along left streambank (some evergreen trees); small areas of emergent aquatic vegetation along both streambanks; mowed lawn dominates left bank, but taller grasses growing in area of new mowing pattern in right bank riparian zone
Water Appearance	4.0	Excellent	Generally, clear water and submerged objects are visible, but low score due to small pockets of iron sheen
Nutrient Enrichment	7.0	Good	Fairly clear water; moderate algal growth on stream substrates
Instream Fish Cover	4.0	Poor	Overhanging vegetation, boulders/cobbles, dense macrophyte beds, bendway weir

Canopy Cover	2.0	Severely Degraded	Less than 20% of water surface shaded within the length of the reach
Overall Score	4.2	Poor

2016		2019	
SVAP Element	Score	Rating	Score	Rating
Channel Condition	3.0	Poor	5.0	Poor
Bank Condition (average)	2.0	Severely Degraded	2.0	Severely Degraded
Riparian Zone (average)	1.0	Severely Degraded	5.5	Fair
Water Appearance	6.0	Fair	4.0	Excellent
Nutrient Enrichment	7.0	Good	7.0	Good
Instream Fish Cover	1.0	Severely Degraded	4.0	Poor
Canopy Cover	0.0	Severely Degraded	2.0	Severely Degraded
Overall Score	2.9	Severely Degraded	4.2	Poor

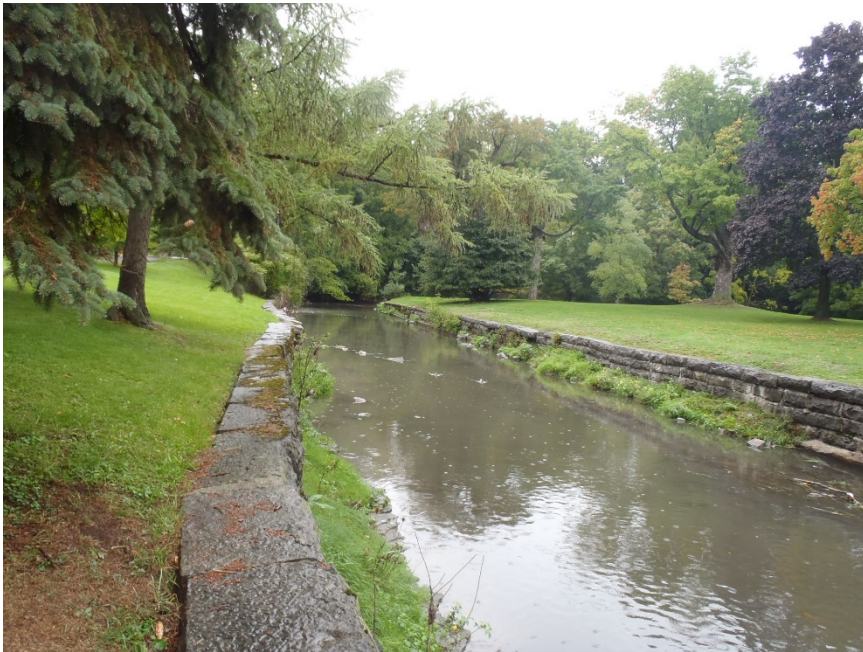
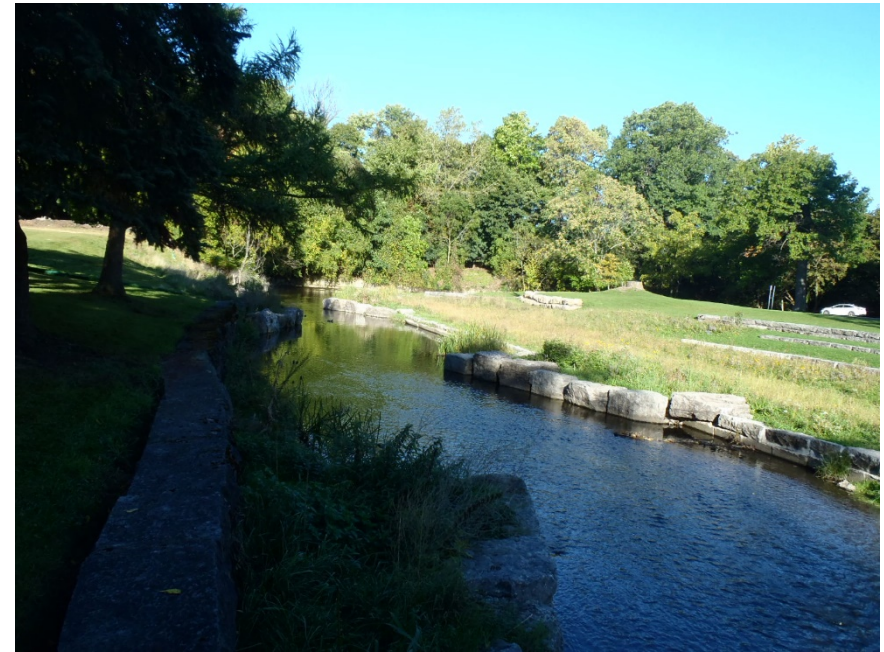
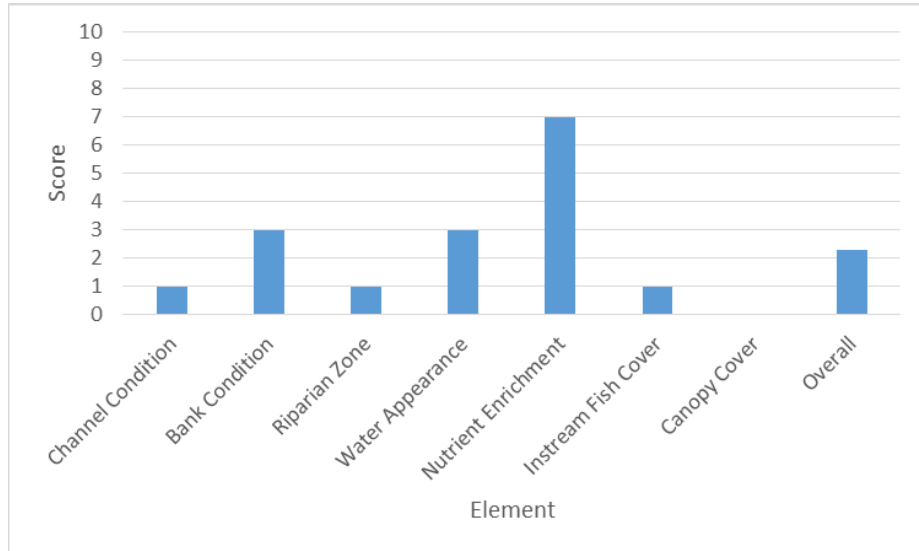
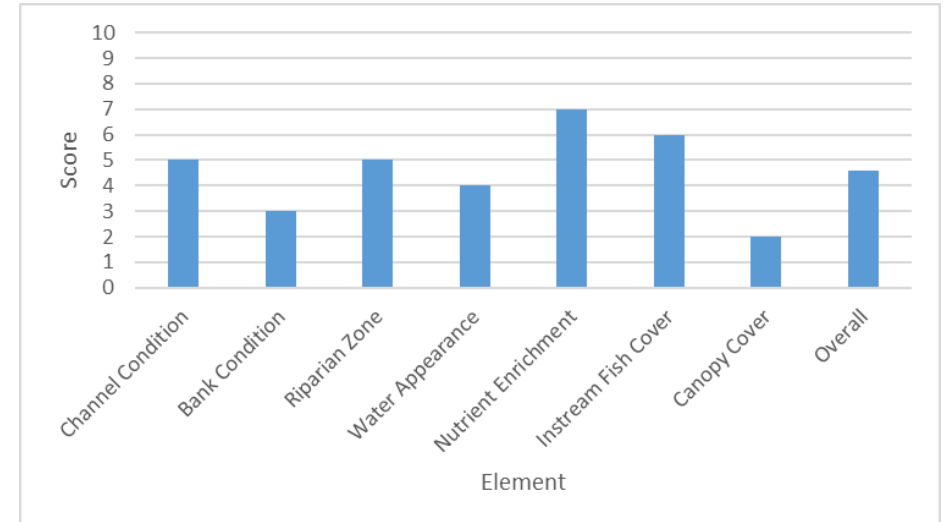
Figure 3.3 Reach 7, located at 42.92432°N, -78.86079°W. Pre-construction SVAP on left (Frothingham et al., 2017) and post-construction on right.

SVAP Element	Score	Rating	Notes
Channel Condition	5.0	Poor	Altered channel, straightened, hard structures; bankfull channel disconnected from floodplain along left streambank
Bank Condition (average)	3.0	Poor	Limestone blocks dominate banks (especially left streambank); streambanks are moderately stable
Riparian Zone (average)	5.0	Fair	Moderate amount of vegetation along left streambank (evergreen trees); small areas of emergent aquatic vegetation along both banks; mowed lawn dominates left bank, but taller grasses growing in area of new mowing pattern along right bank riparian zone
Water Appearance	4.0	Poor	Generally, clear water and submerged objects are visible, but low score due to an oil/bacterial sheen present behind a bendway weir
Nutrient Enrichment	7.0	Good	Fairly clear water; moderate algal growth on stream substrates
Instream Fish Cover	6.0	Fair	Overhanging vegetation, logs, riffles, dense macrophyte beds, bendway weir

Canopy Cover	2.0	Severely Degraded	Less than 20% of water surface shaded within the length of the reach
Overall Score	4.6	Poor

2016		2019	
SVAP Element	Score	Rating	Score	Rating
Channel Condition	1.0	Severely Degraded	5.0	Poor
Bank Condition (average)	3.0	Poor	3.0	Poor
Riparian Zone (average)	1.0	Severely Degraded	5.0	Fair
Water Appearance	3.0	Poor	4.0	Poor
Nutrient Enrichment	7.0	Fair	7.0	Good
Instream Fish Cover	1.0	Severely Degraded	6.0	Fair
Canopy Cover	0.0	Severely Degraded	2.0	Severely Degraded
Overall Score	2.3	Severely Degraded	4.6	Poor

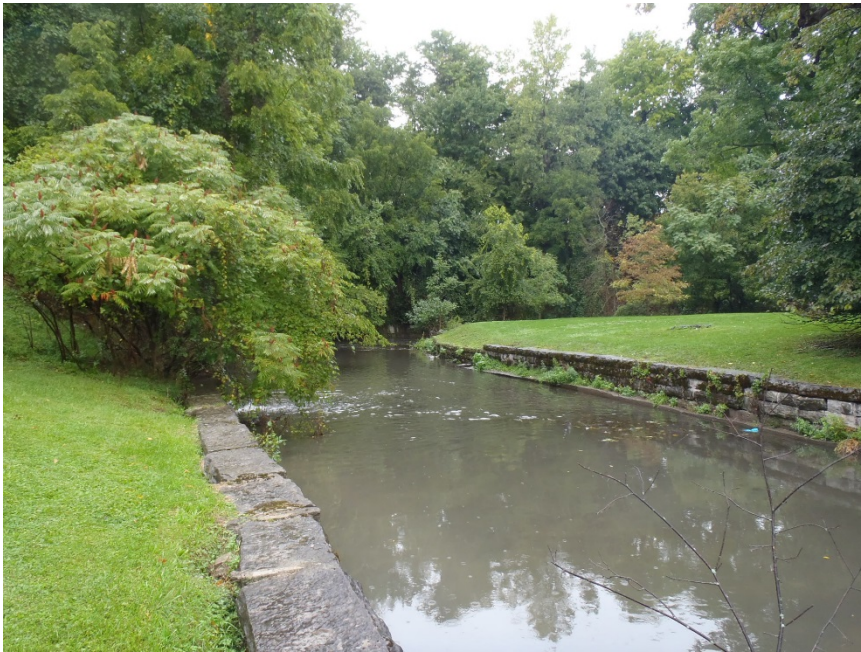
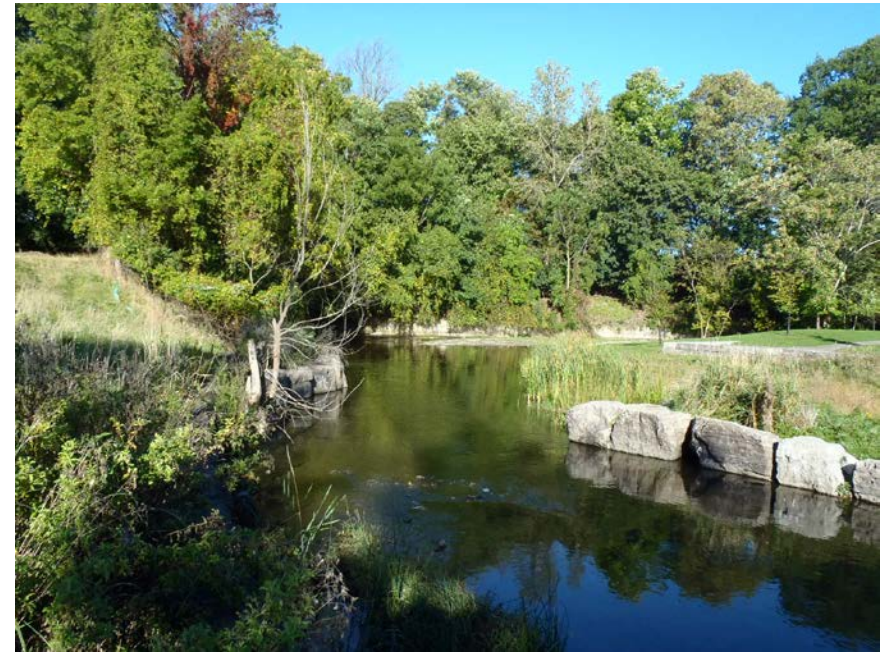
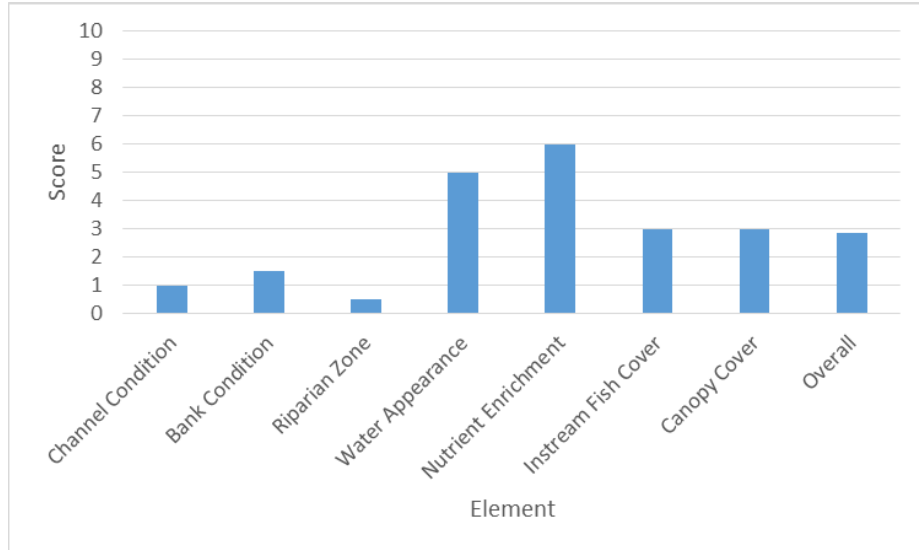
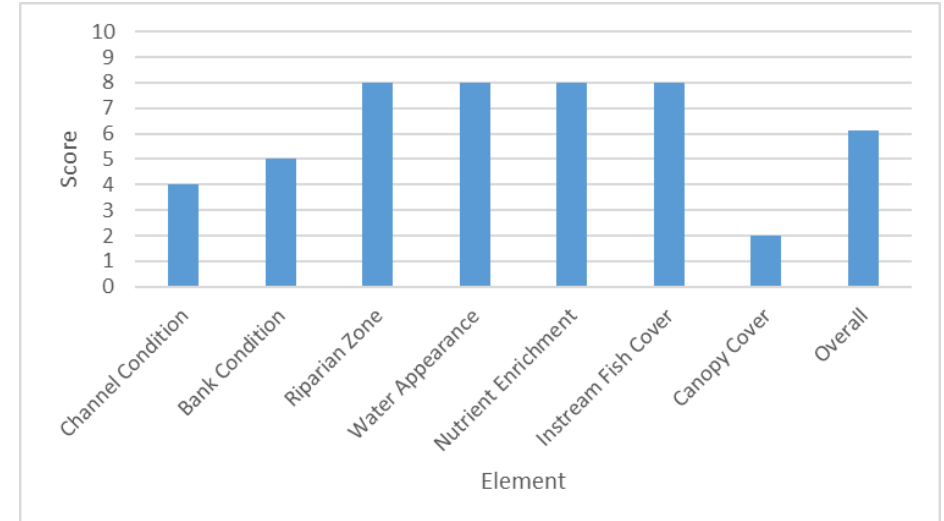
Figure 3.4 Reach 8, located at 42.92459°N, -78.86149°W. Pre-construction SVAP on left (Frothingham et al., 2017) and post-construction on right.

SVAP Element	Score	Rating	Notes
Channel Condition	4.0	Poor	Altered channel, straightened, hard structures; bankfull channel connected to floodplain along this reach, especially at the downstream end
Bank Condition (average)	5.0	Fair	Limestone blocks dominate banks; streambanks are moderately stable
Riparian Zone (average)	8.0	Good	Vegetation (primarily tall grasses and sedges) extends one bankfull channel width from the top of the bankfull channel on both streambanks along the majority of the length of the reach
Water Appearance	8.0	Fair	Water clear and submerged objects are visible
Nutrient Enrichment	8.0	Good	Fairly clear water; moderate algal growth on stream substrates
Instream Fish Cover	8.0	Good	Overhanging vegetation, logs, riffles, dense macrophyte beds, cobble/boulders, deep pool, bendway weir
Canopy Cover	2.0	Severely Degraded	Less than 20% of water surface shaded within the length of the reach

Overall Score	6.1	Fair

2016		2019	
SVAP Element	Score	Rating	Score	Rating
Channel Condition	1.0	Severely Degraded	4.0	Poor
Bank Condition (average)	1.5	Severely Degraded	5.0	Fair
Riparian Zone (average)	0.5	Severely Degraded	8.0	Good
Water Appearance	5.0	Fair	8.0	Fair
Nutrient Enrichment	6.0	Fair	8.0	Good
Instream Fish Cover	3.0	Poor	8.0	Good
Canopy Cover	3.0	Poor	2.0	Severely Degraded
Overall Score	2.9	Severely Degraded	6.1	Fair

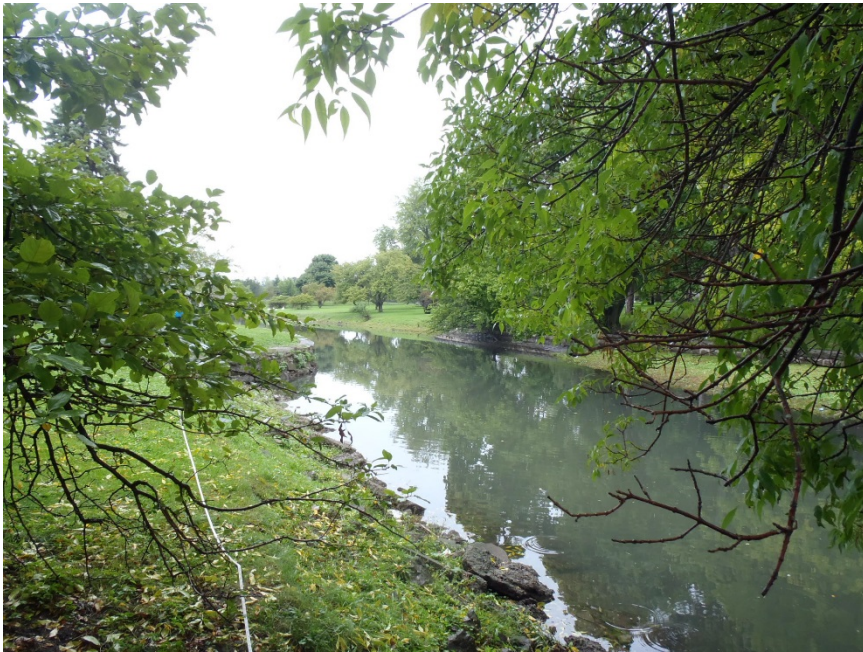
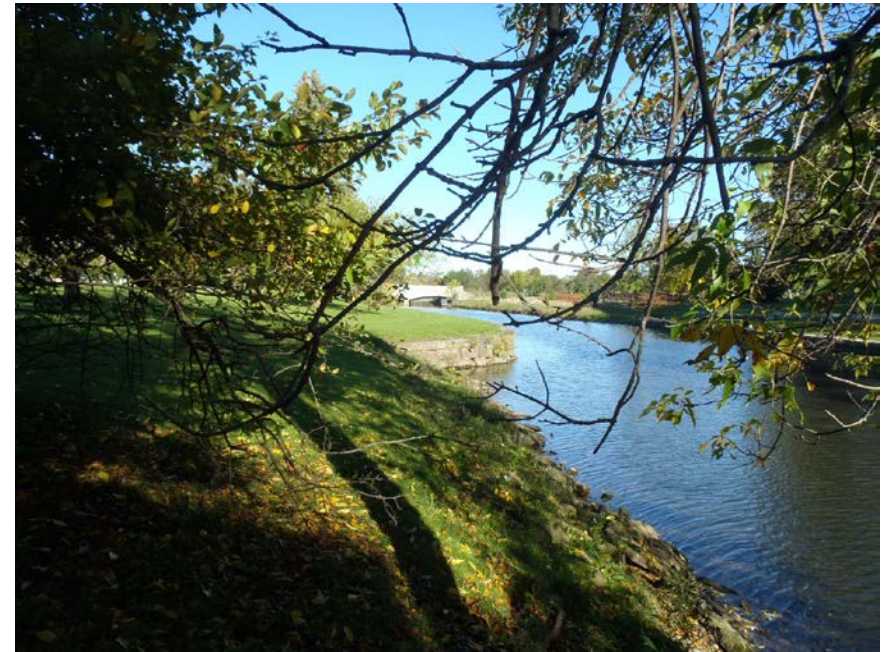
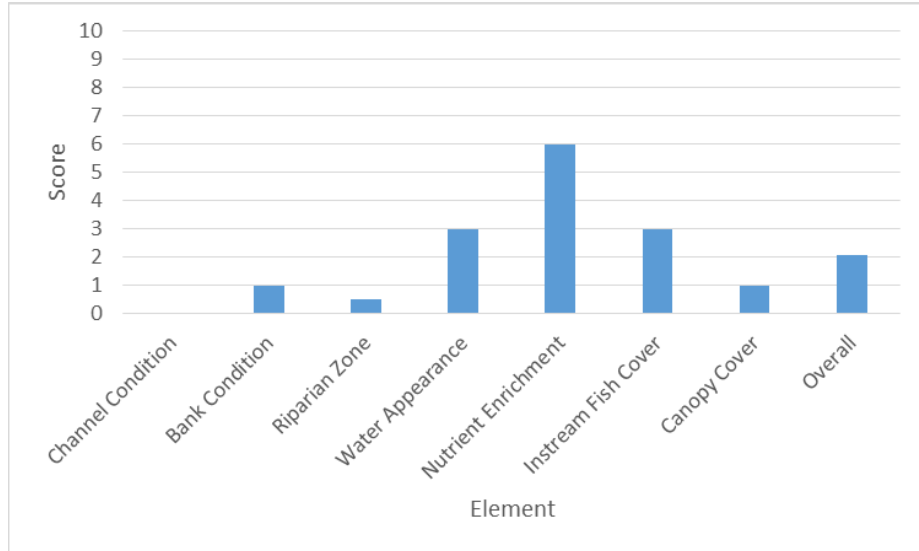
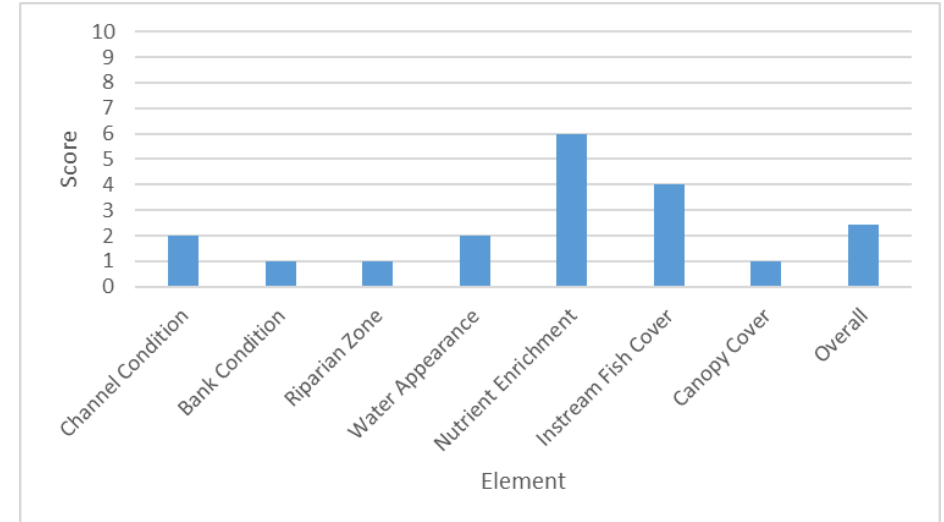
Figure 3.5 Reach 20, located at 42.9278°N, -78.86447°W. Pre-construction SVAP on left (Frothingham et al., 2017) and post-construction on right.

SVAP Element	Score	Rating	Notes
Channel Condition	2.0	Severely Degraded	Altered channel, straightened, hard structures; bankfull channel disconnected from floodplain along both streambanks
Bank Condition (average)	1.0	Severely Degraded	Limestone blocks dominate both streambanks; banks are stable
Riparian Zone (average)	1.0	Severely Degraded	Little to no vegetation in riparian zone along both streambanks; mowed lawn dominates riparian zone
Water Appearance	2.0	Severely Degraded	Water was turbid
Nutrient Enrichment	6.0	Fair	Fairly clear or slightly greenish water; moderate algal growth on stream substrates
Instream Fish Cover	4.0	Poor	Overhanging vegetation, log, undercut bank
Canopy Cover	1.0	Severely Degraded	Less than 20% of water surface shaded within the length of the reach
Overall Score	2.4	Severely Degraded

2016		2019	
SVAP Element	Score	Rating	Score	Rating
Channel Condition	0.0	Severely Degraded	2.0	Severely Degraded
Bank Condition (average)	1.0	Severely Degraded	1.0	Severely Degraded
Riparian Zone (average)	0.5	Severely Degraded	1.0	Severely Degraded
Water Appearance	3.0	Poor	2.0	Severely Degraded
Nutrient Enrichment	6.0	Fair	6.0	Fair
Instream Fish Cover	3.0	Poor	4.0	Poor
Canopy Cover	1.0	Severely Degraded	1.0	Severely Degraded
Overall Score	2.1	Severely Degraded	2.4	Severely Degraded

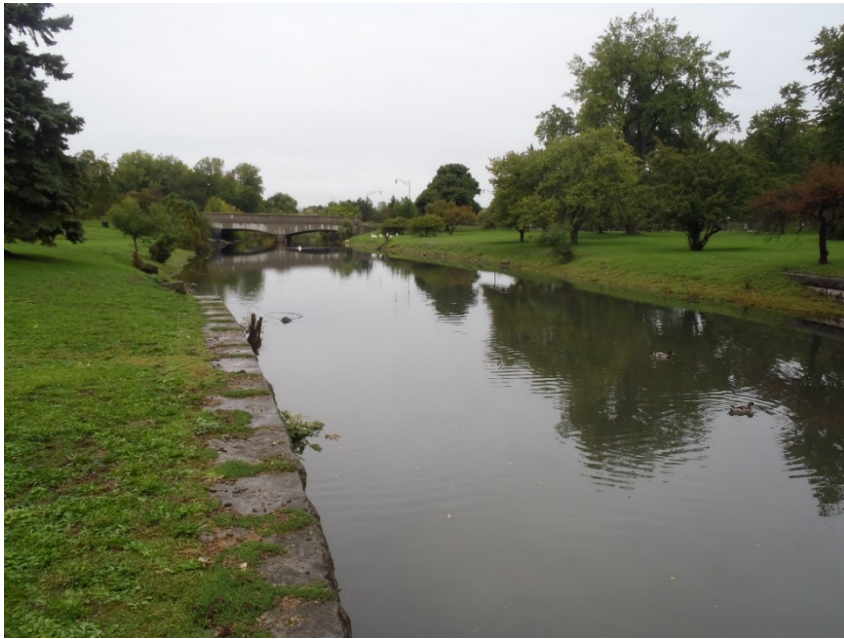
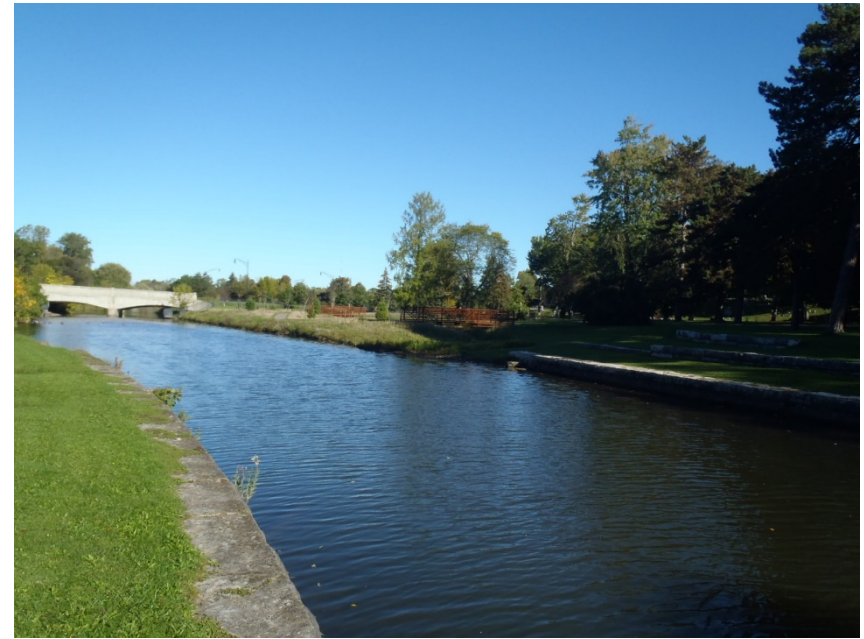
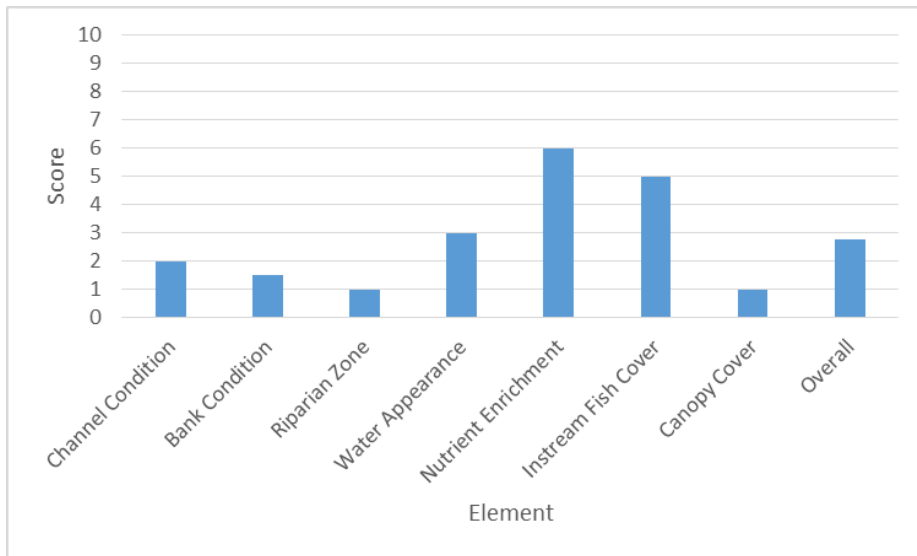
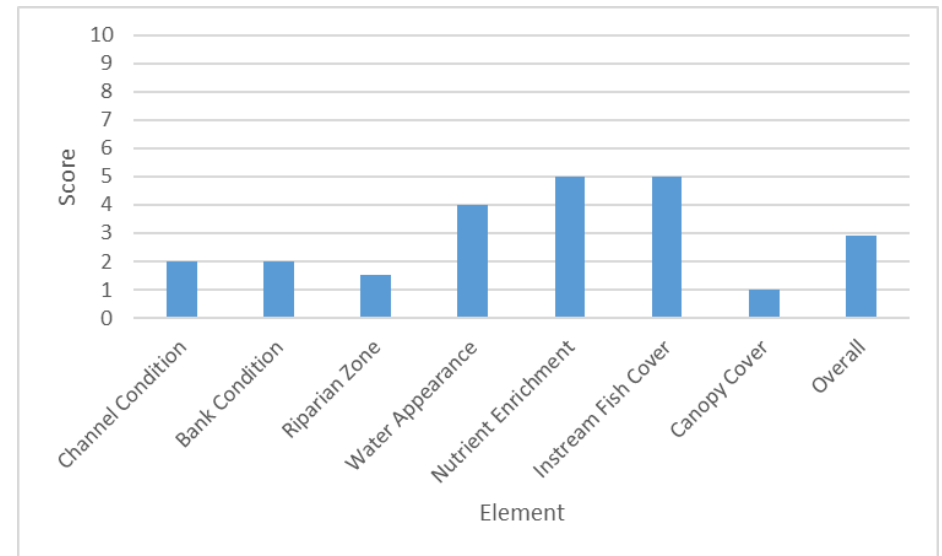
Figure 3.6 Reach 21, located at 42.92825°N, -78.8648°W. Pre-construction SVAP on left (Frothingham et al., 2017) and post-construction on right.

SVAP Element	Score	Rating	Notes
Channel Condition	2.0	Severely Degraded	Altered channel, straightened, hard structures; bankfull channel disconnected from floodplain along both streambanks (except in wetland area at the downstream end of this reach)
Bank Condition (average)	2.0	Severely Degraded	Limestone blocks dominate streambanks; banks are stable
Riparian Zone (average)	1.5	Severely Degraded	Little to no vegetation in riparian zone along both streambanks; mowed lawn dominates riparian zone (excluding wetland project area)
Water Appearance	4.0	Poor	Water was turbid
Nutrient Enrichment	5.0	Fair	Greenish water; abundant algal growth on hard surfaces
Instream Fish Cover	5.0	Fair	Log, boulder/cobble, bendway weir, wetland adjacent to the bank
Canopy Cover	1.0	Severely Degraded	Less than 20% of water surface shaded within the length of the reach
Overall Score	2.9	Severely Degraded

2016		2019	
SVAP Element	Score	Rating	Score	Rating
Channel Condition	2.0	Severely Degraded	2.0	Severely Degraded
Bank Condition (average)	1.5	Severely Degraded	2.0	Severely Degraded
Riparian Zone (average)	1.0	Severely Degraded	1.5	Severely Degraded
Water Appearance	3.0	Poor	4.0	Poor
Nutrient Enrichment	6.0	Fair	5.0	Fair
Instream Fish Cover	5.0	Fair	5.0	Fair
Canopy Cover	1.0	Severely Degraded	1.0	Severely Degraded
Overall Score	2.8	Severely Degraded	2.9	Severely Degraded

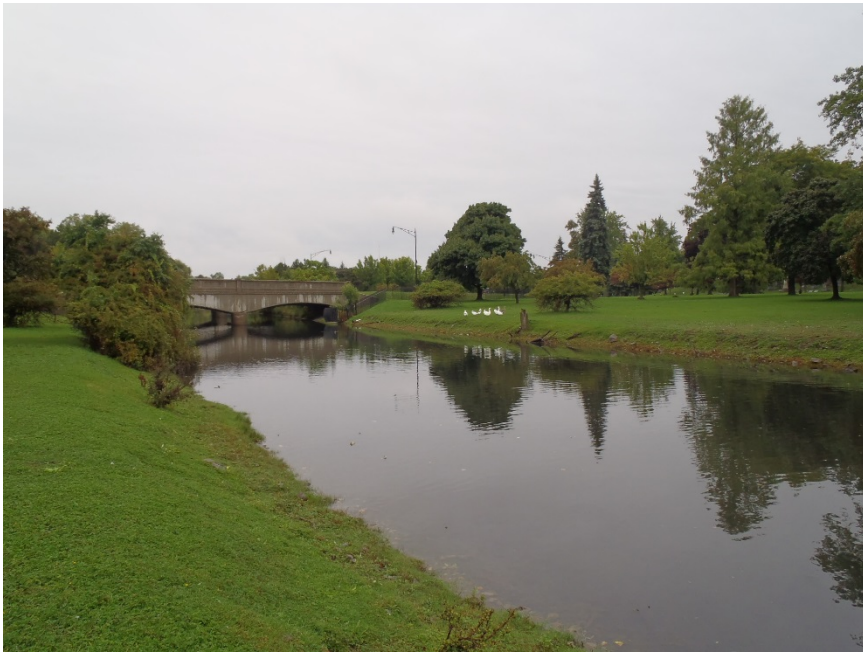
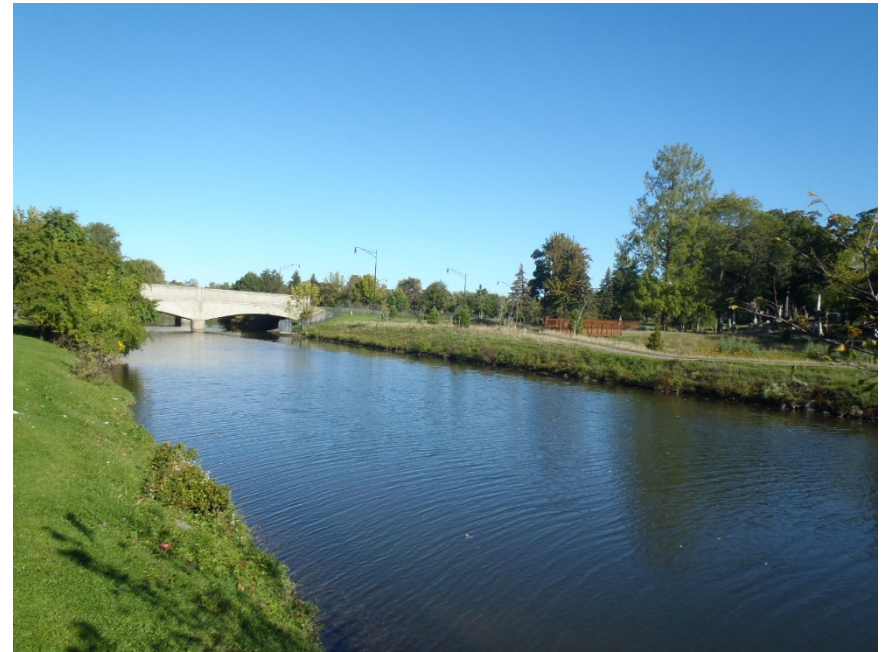
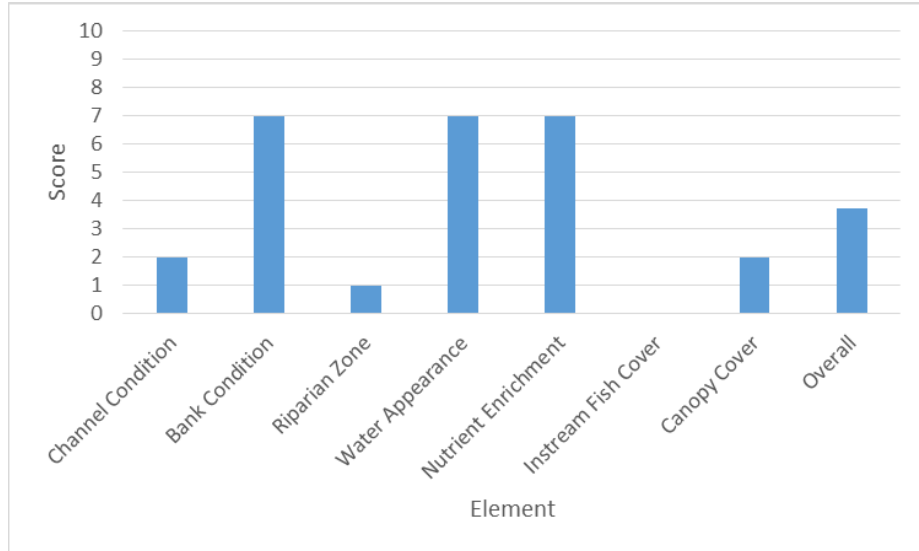
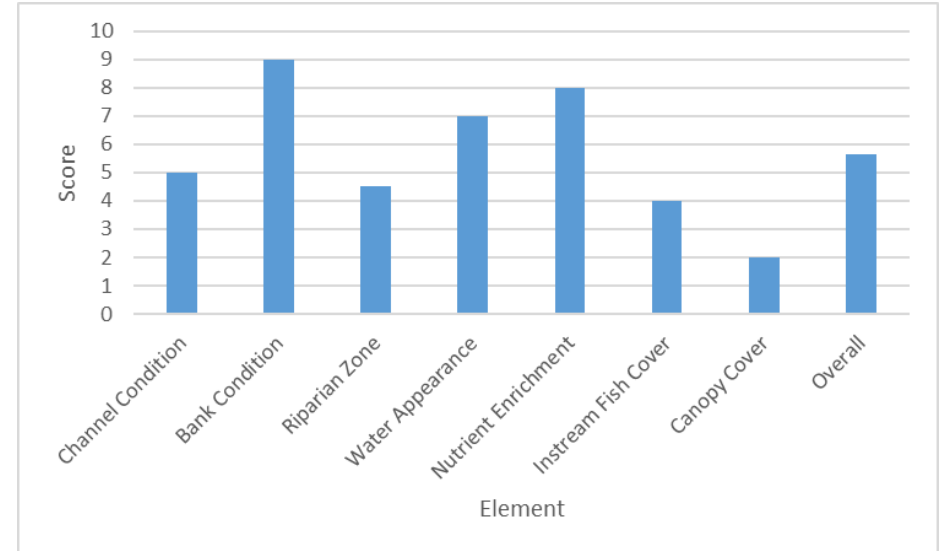
Figure 3.7 Reach 22, located at 42.92853°N, -78.86523°W. Pre-construction SVAP on left (Frothingham et al., 2017) and post-construction on right.

SVAP Element	Score	Rating	Notes
Channel Condition	5.0	Fair	Altered channel; limited hard structures at upstream end of reach; channel connected to floodplain/wetland project area along right bank
Bank Condition (average)	9.0	Excellent	Limited hard structures; streambanks moderately stable
Riparian Zone (average)	4.5	Poor	Mowed lawn dominates riparian zone along both streambanks in upstream end of reach (total length of riparian zone along left bank); natural vegetation in wetland project area along right bank
Water Appearance	7.0	Good	Water was slightly turbid
Nutrient Enrichment	8.0	Good	Fairly clear or slightly greenish water; moderate algal growth on stream substrates
Instream Fish Cover	4.0	Poor	Overhanging vegetation, undercut banks, wetland adjacent to the right streambank
Canopy Cover	2.0	Severely Degraded	Less than 20% of water surface shaded within the length of the reach
Overall Score	5.6	Fair

2016		2019	
SVAP Element	Score	Rating	Score	Rating
Channel Condition	2.0	Severely Degraded	5.0	Fair
Bank Condition (average)	7.0	Good	9.0	Excellent
Riparian Zone (average)	1.0	Severely Degraded	4.5	Poor
Water Appearance	7.0	Good	7.0	Good
Nutrient Enrichment	7.0	Good	8.0	Good
Instream Fish Cover	0.0	Severely Degraded	4.0	Poor
Canopy Cover	2.0	Severely Degraded	2.0	Severely Degraded
Overall Score	3.7	Poor	5.6	Fair
