## **VISUALIZING WATER QUALITY TRENDS IN CHIANG MAI RICE PADDIES: POSSIBLE LINKS BETWEEN ENVIRONMENT AND HEALTH RISKS**

**ABSTRACT:** *Liver fluke (Opisthorchis viverrini) infection is a health concern throughout Thailand. Liver flukes use the Bithynia spp. snails, which inhabit rice paddy fields, as first intermediate hosts in their life cycle. Water quality and environmental factors could have an effect on snail distribution and their incidence of parasitic infection. Another area of health concern is the presence of Escherichia coli in the paddy water and the risk for human contact. Four rice paddy fields were studied around the Chiang Mai area. Sites 1 through 3 included an irrigation canal and rice paddy and Site 4 was only a rice paddy. Water quality data were automatically recorded every 15 minutes at sites 1 through 3 (canals) over a 48-hour period using a Hydrolab Datasonde 4a, which measures temperature, pH, turbidity, conductivity, and dissolved oxygen. Water grab samples were tested for the presence of E. coli. Snails were collected, identified, and their parasitic infection was determined. Bacteria levels typically were higher in the irrigation canals than in the rice

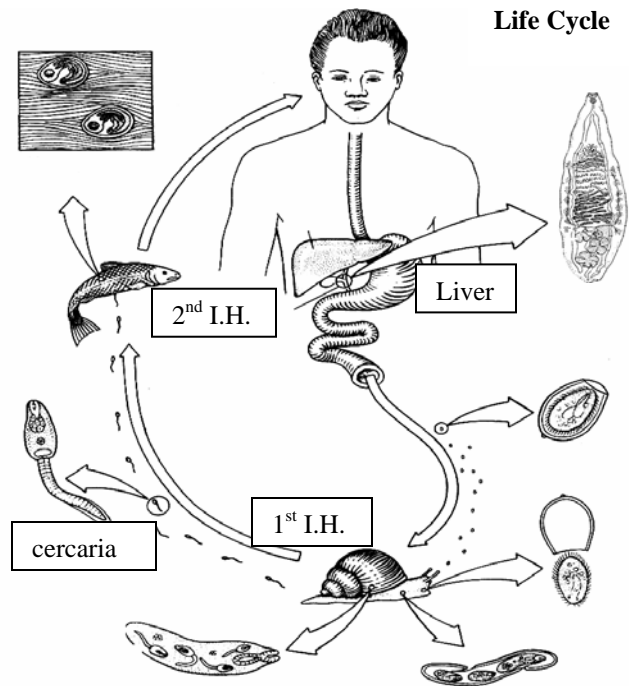
Figure 1. The life cycle of the liver fluke, *Opisthorchis viverrini*. The snail serves as the first intermediate host (IH), followed by the cyprinid fish as the secondary intermediate host. The adult liver fluke is found in the bile tract of a human.

Infection by the liver fluke, *Opisthorchis viverrini* is a human health concern in Northern Thailand. It has been estimated that in North and Northeastern Thailand, seven million people are infected (Upatham and Viyanant, 2003) resulting in an economic cost in the order of \$84.6 million (1991 USD) a year (Loaharanu and Sormani, 1991). *Bithynia* spp. snails are first intermediate hosts in the fluke's life cycle and, in particular for this region, the liver flukes use *Bithynia (Digoniostoma) siamensis funiculata* for their host (Figure 1). The fluke eggs

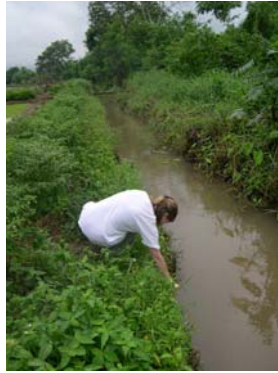
Figure 4. Bacteria sampling at Site 2, irrigation canal.

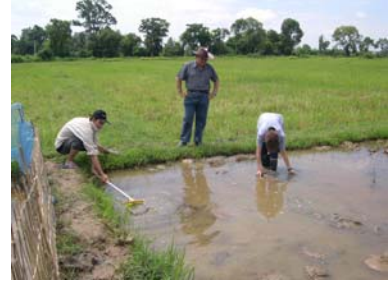
Figure 5. Snail sampling at Site 3, rice paddy.

These sites were studied for a two week period. At each site, snails were sampled using hand collection in 4-m<sup>2</sup> plots for 10-minute intervals. Subsequently, the snails were taken to the lab, identified, and their parasitic infection was determined using crushing and shedding methods. On snail sampling days, a Hydrolab Datasonde 4a was used to collect water quality data for that particular day and time. These data included the temperature, dissolved oxygen (concentration and percent saturation), conductivity, turbidity, and pH of the water. During the second week, the Hydrolab was left in the irrigation canal at each site (1-3) for a 48-hour period to automatically log water quality data at 15-minute intervals. Water grab samples were tested for the presence of *E. coli* at each site/subsite, using Coliscan<sup>®</sup> Easygel<sup>®</sup> kits. At each subsite, 1-ml of water was collected, plated, and allowed to incubate at room temperature for 48-hours before bacteria colonies were counted. The physical environment (soil type, land use, topography, source water) was characterized in ArcView using various available digital layers, satellite images, and air photos.
